TRAMRAIL
By Gorbel Inc.

CASTELLATED “ARCH” BEAMS

Pose A Potential Risk To Workers

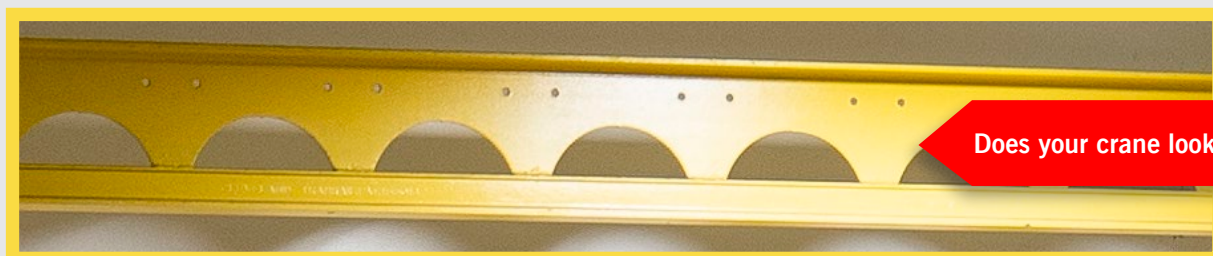
The welds in Arch Beam can weaken over time and experience Martensitic Failure, resulting in the bottom rail peeling away from the web plate. This safety issue should be brought to the attention of management immediately.

Does your crane look like this?

Due to the seriousness of potential Martensitic Failure in Arch Beams, Gorbel recommends that any castellated beam is inspected regularly, based on capacity and lift frequency, by a certified engineer. We also strongly recommended putting a replacement plan in place based on the inherent risks associated with continued use of castellated beam and the cost and time of frequent inspections.

- Loading Tables in old catalogs were calculated for new beam as built at that time
- As of this date (March 2, 1992) all Arch Beam should be replaced with Tarca® due to its age, and De-Rating of capacity is no longer advised
- Arch Beam should also be replaced with Tarca® versus ANY repair due to age and many years of fatigue
